Report of Investigation 214

Evaluation of the durability of granite
in architectural monuments

Elena Panova, Dmitri Vlasov and Hannu Luodes (eds)

Evaluation of the durability of granite in architectural monuments was carried out as part of the project "Efficient use of natural stone in the Leningrad region and South-East Finland". The focus of the research was on rapakivi granite, since it is the most common and most widely used local stone material.

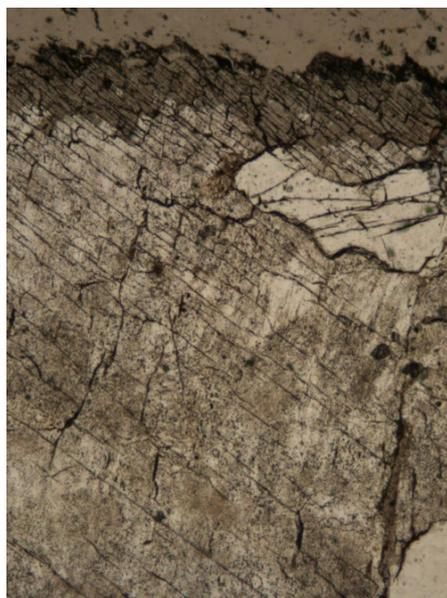
Fig. 8. Cracks in the weathered surface of granite (upper part of the photo). Nicols crossed, magnification 90x.

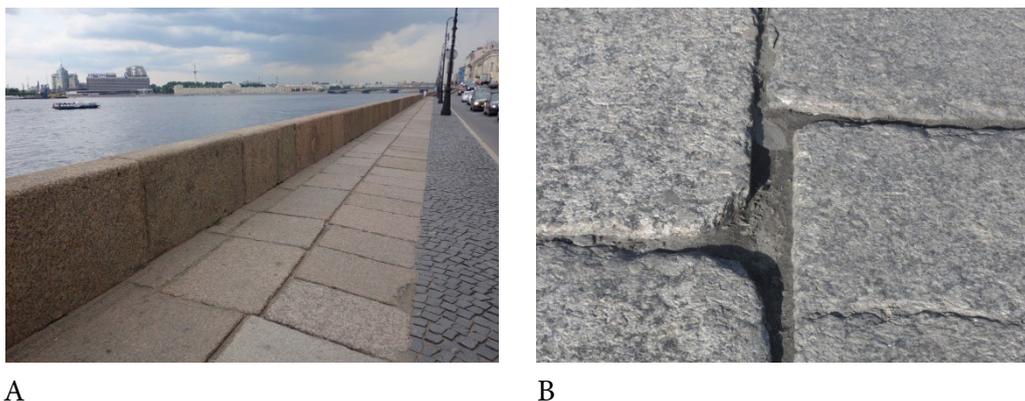
Fig. 12. Granite paving stones laid in the 1760s and gaps between them (right)

The process of physical destruction may be traced by comparing recently laid slabs with the state of the stone used for paving sidewalks in the 18th century (Figs 11 & 12).

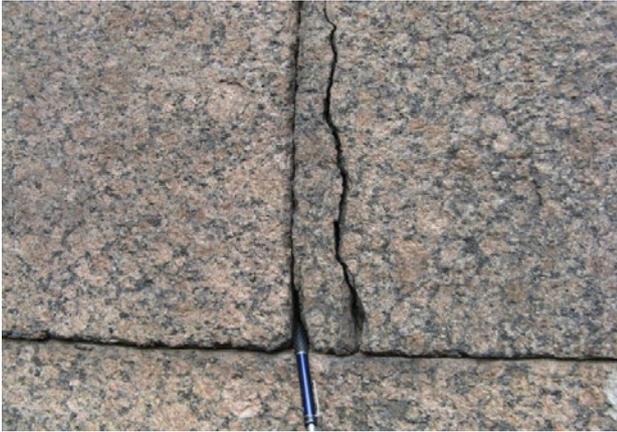
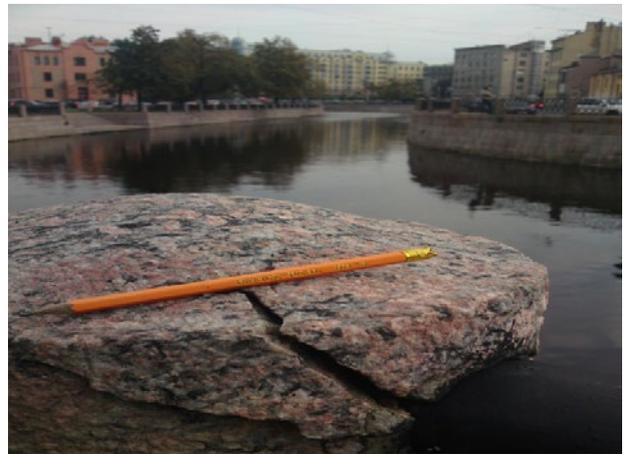
ID. Fissures

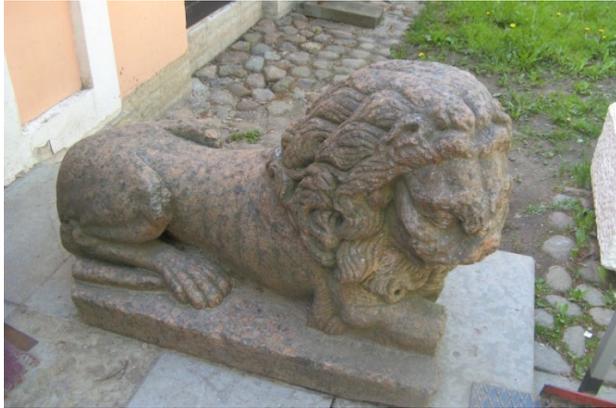
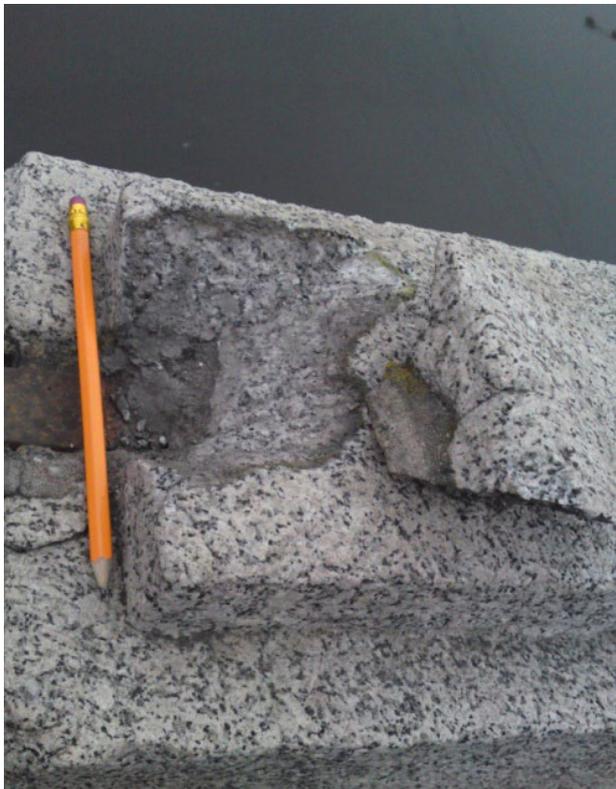
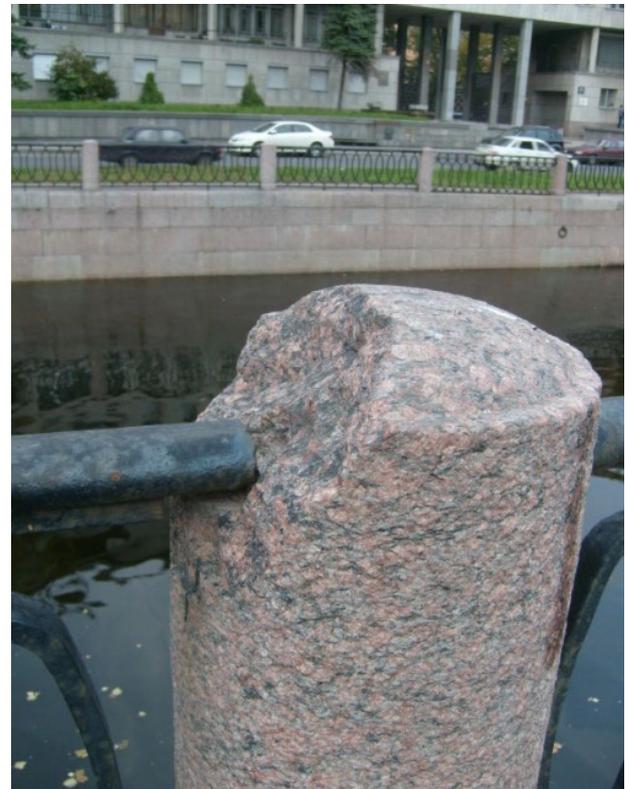
IE. Loss of rock fragments, chipping

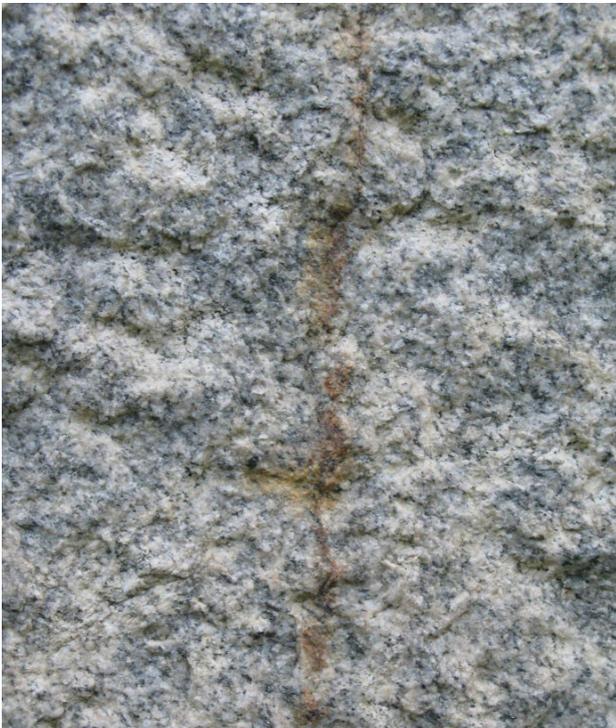
c. Oxidation of sulphide minerals in a fracture

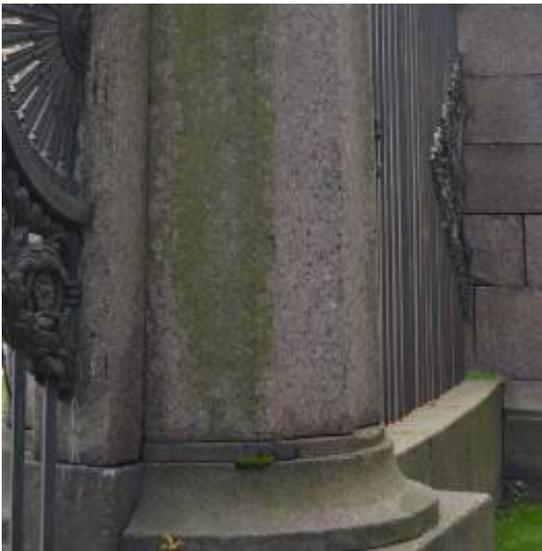
Fig. 35. A local biofilm dominated by algae on a granite column.

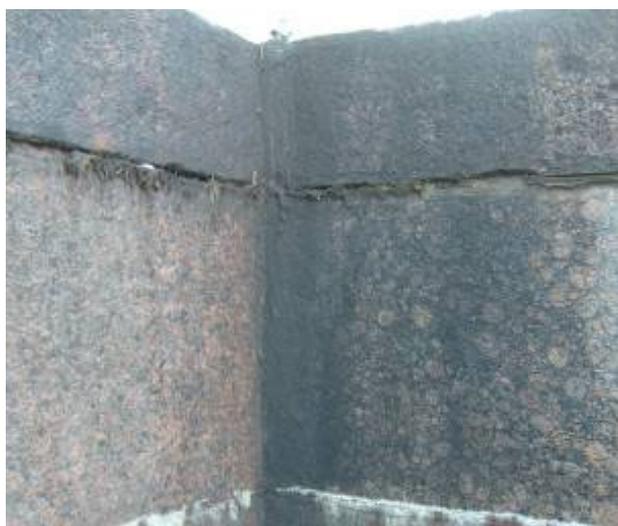
Fig. 47. Black crust, formed a biofilm (dominated by fungi) and atmospheric pollution.

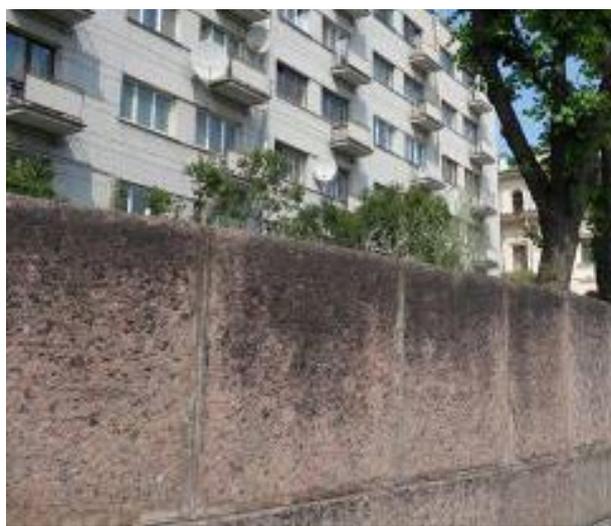
Fig. 48. Black biofilms dominated by fungi on the surface of granite.

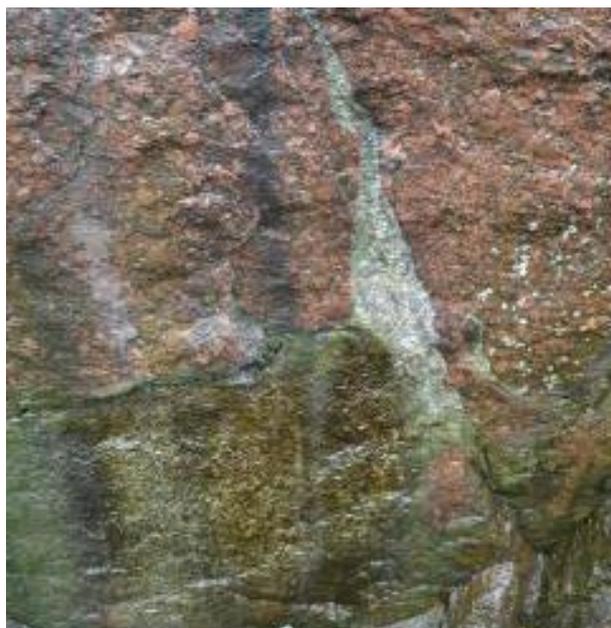
Fig. 50. Biofilm with a dominance of cyanobacteria in a zone of high humidity.

Often, dark films associate with the development of cyanobacteria. Such films can be observed in places with a constant high humidity. They were found on many buildings in Vyborg and the Peter and Paul fortress in St. Petersburg. Their colour varies from dark green to almost black (Figs 49–52). Cyanobacteria secrete mucus, which protects them from drying out. In areas with an intensive development of cyanobacteria, they create the conditions for the development and accumulation of saprophytic bacteria. In our study, their

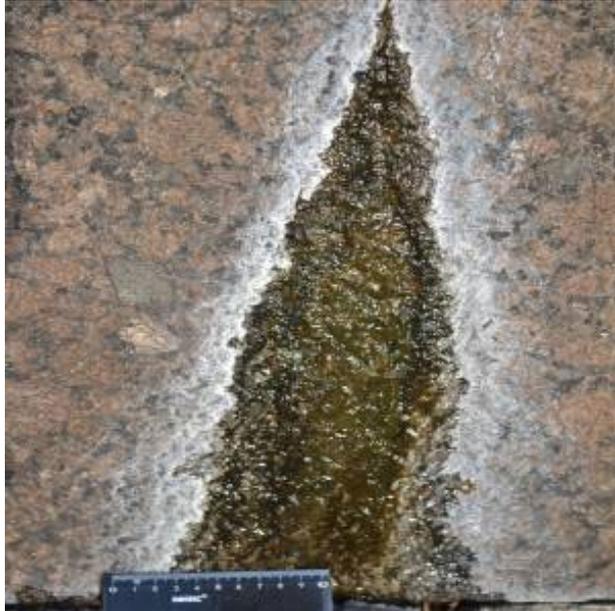
Fig. 51. Biofilm with a predominance of cyanobacteria at the site of infiltration of moisture from a crack.

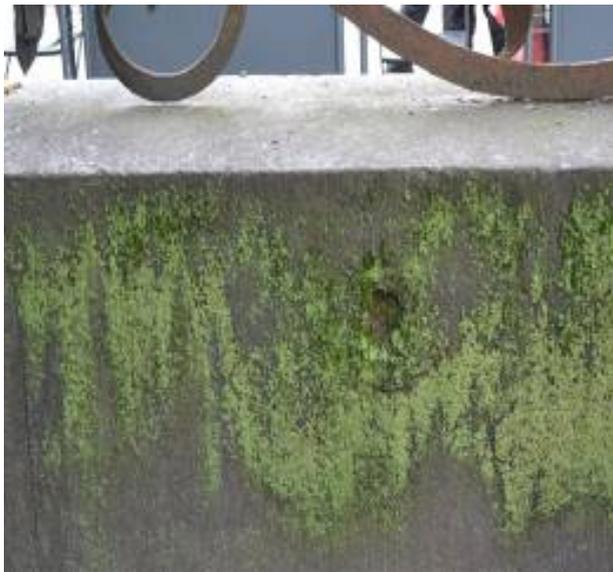
Fig. 65. Fouling of granite by the foliose lichen *Phaeophyscia orbicularis*

Often crustose and foliose lichens cover a large surface of granite (Figs. 66–70). Lichens often tend to grow in the irregularities on the granite surface, including eroded areas, potholes, cracks and chips, often of anthropogenic origin.

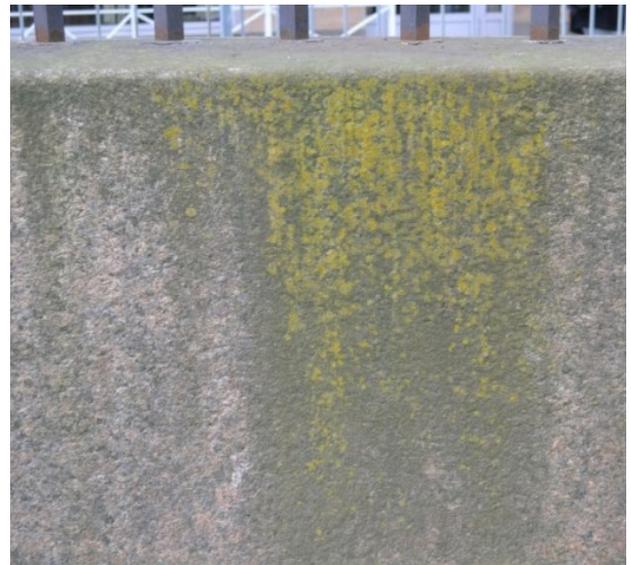
Fig. 66. Fouling of granite by the crustose lichen *Candeliella* sp.

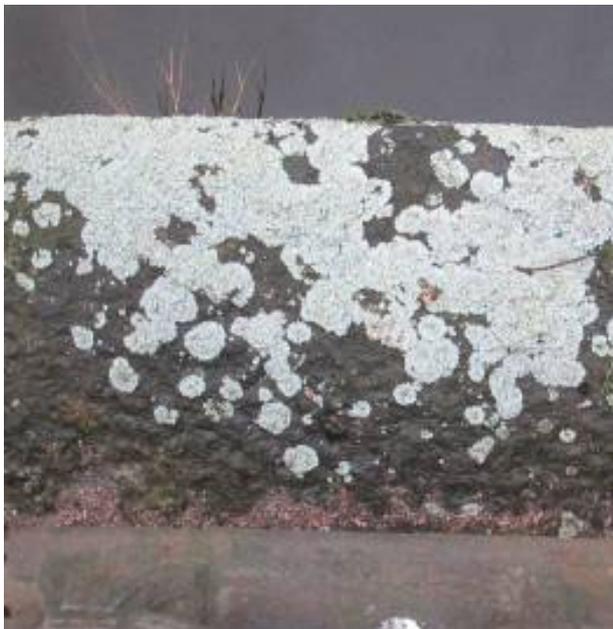
Fig. 67. Fouling of granite by the foliose lichen *Physcia caesia*

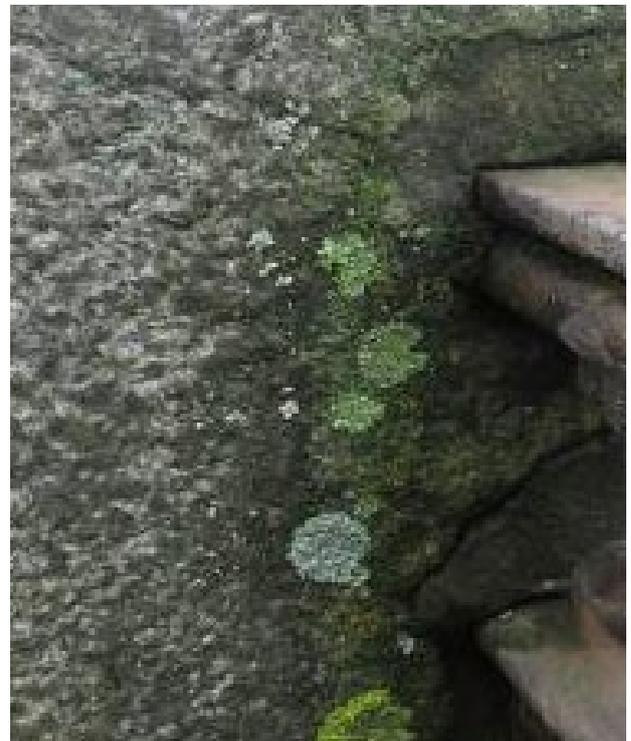
Fig. 68. Fouling by the lichens *Phaeophyscia orbicularis*, *Hypogymnia physodes*, *Xanthoria parietina*

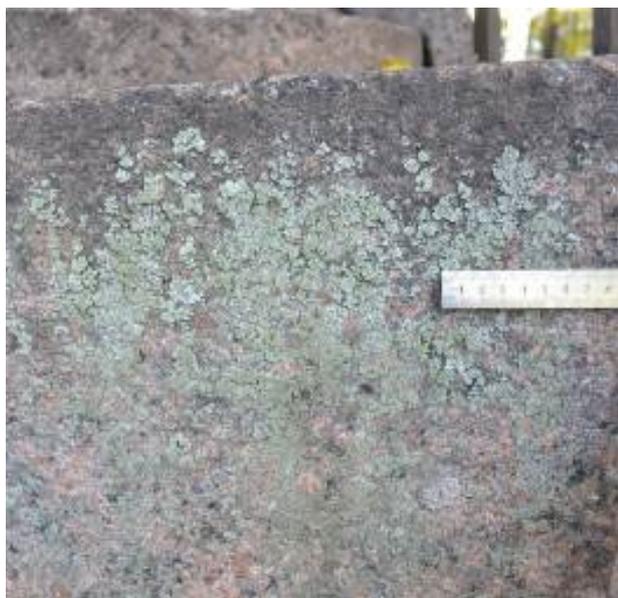
Fig. 69 Fouling of granite by the lichen from Physciaceae familiaeae.

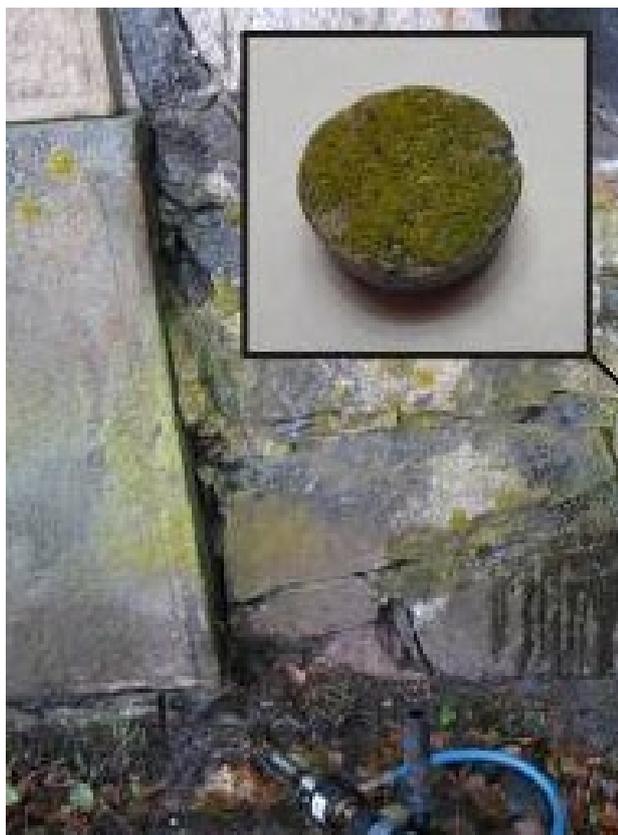
Fig. 70. Crustose lichen on the surface of granite

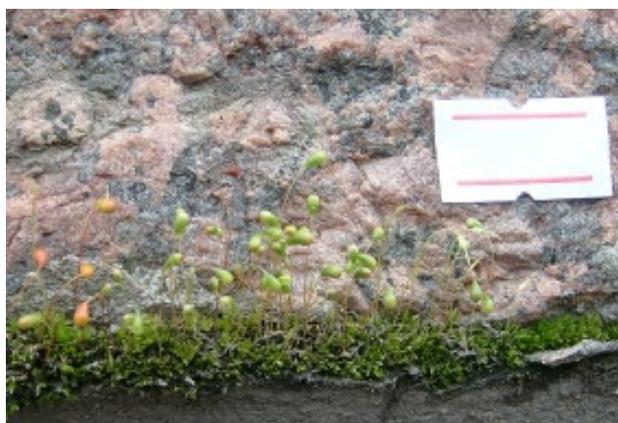
Fig. 71. The moss *Pohlia nutans* (Hedw.) Lindb. on granite

Mosses of 3 species are ubiquitous: *Ceratodon purpureus* (Hedw.) Brid., *Pohlia nutans* (Hedw.) Lindb. and *Physcomitrium* sp. (definition by L. E. Kurbatova). They trap moisture and create conditions for the gradual destruction of granite (Figs 71–74). Under the mosses, it is possible to observe the formation of a thin primary layer of soil, which is composed of dead fragments of mosses, particles of damaged granite, as well as sand and dust particles from the external environment. The large number of mica and feldspar particles (granite components) in the samples, which are accumulated in rhizoids, points to the destructive role of mosses.

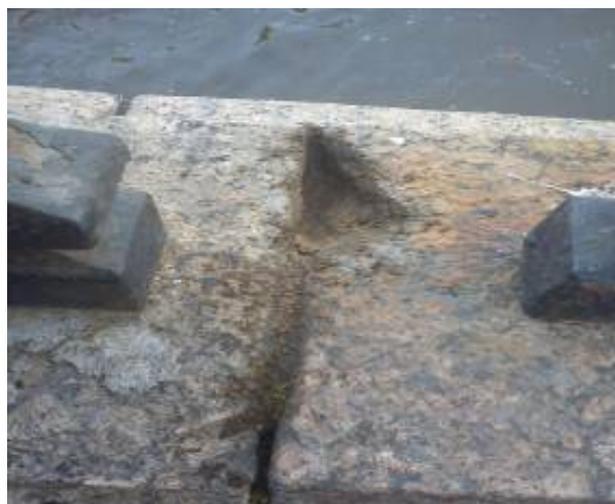
Fig. 74 Cavens in granite visible after removal of the mosses.

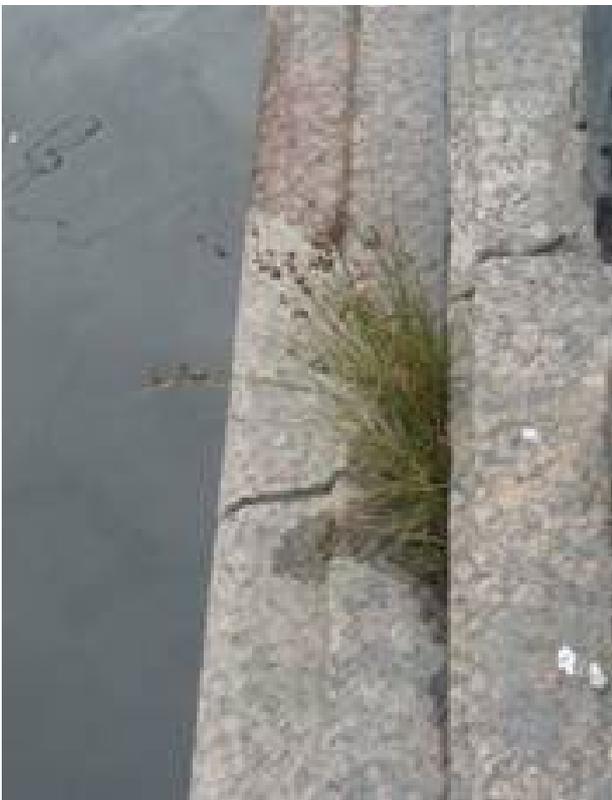
Fig. 86. The herbaceous plant *Carex* sp. on granite

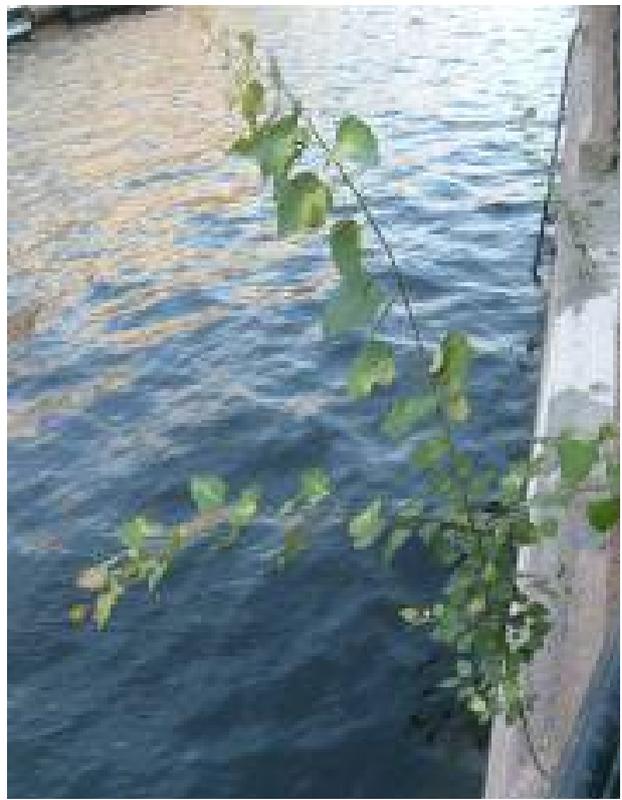
Fig. 88. The woody plant *Betula* sp. on granite

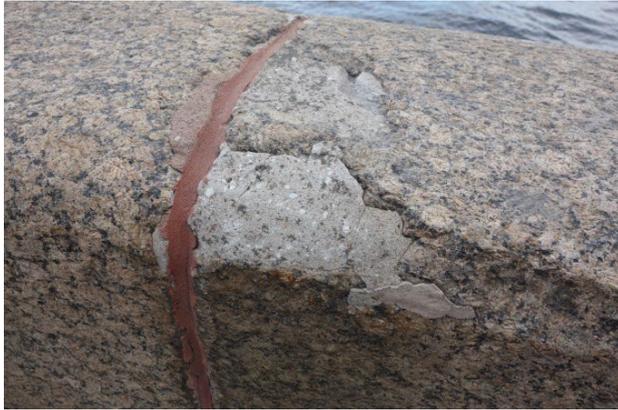
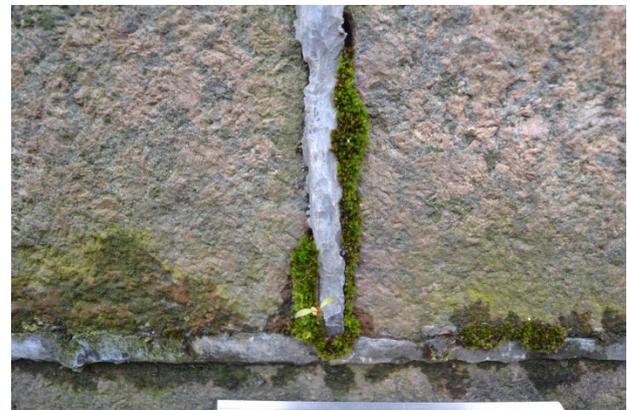
IIIB. Cementation of stone defects

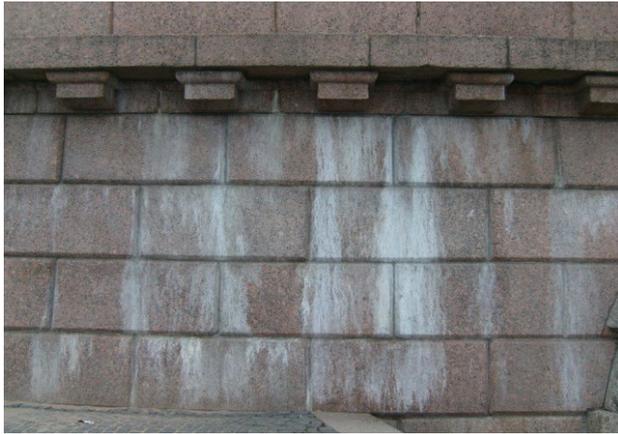
IIIC. Efflorescence

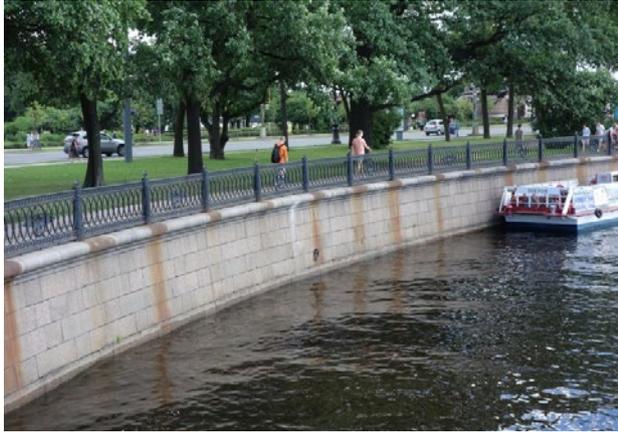
IIID. Streaks from corrosion of metal constructions

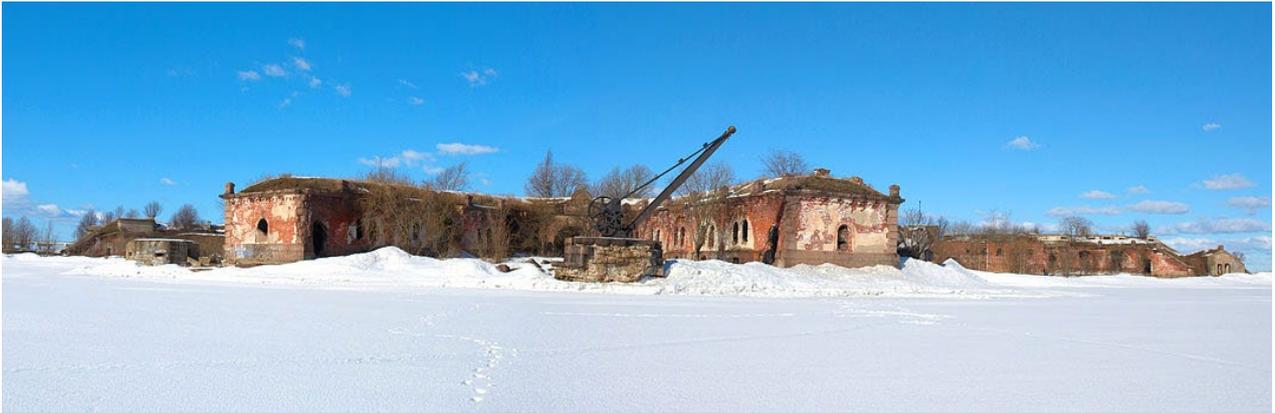
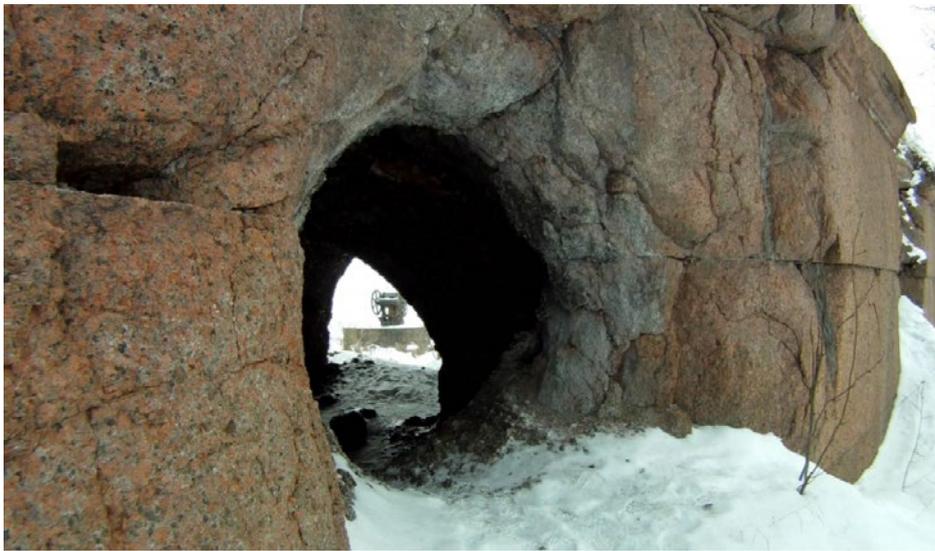
IIIG. Catastrophic destructions
